**RADIOLOGICAL CHARACTERIZATION REPORT FOR
FUSRAP PROPERTIES IN THE ST. LOUIS, MISSOURI, AREA**

VOLUME I

MARCH 1990

**K. C. Noey
C. M. Sekula
Bechtel National, Inc.
Oak Ridge, Tennessee**

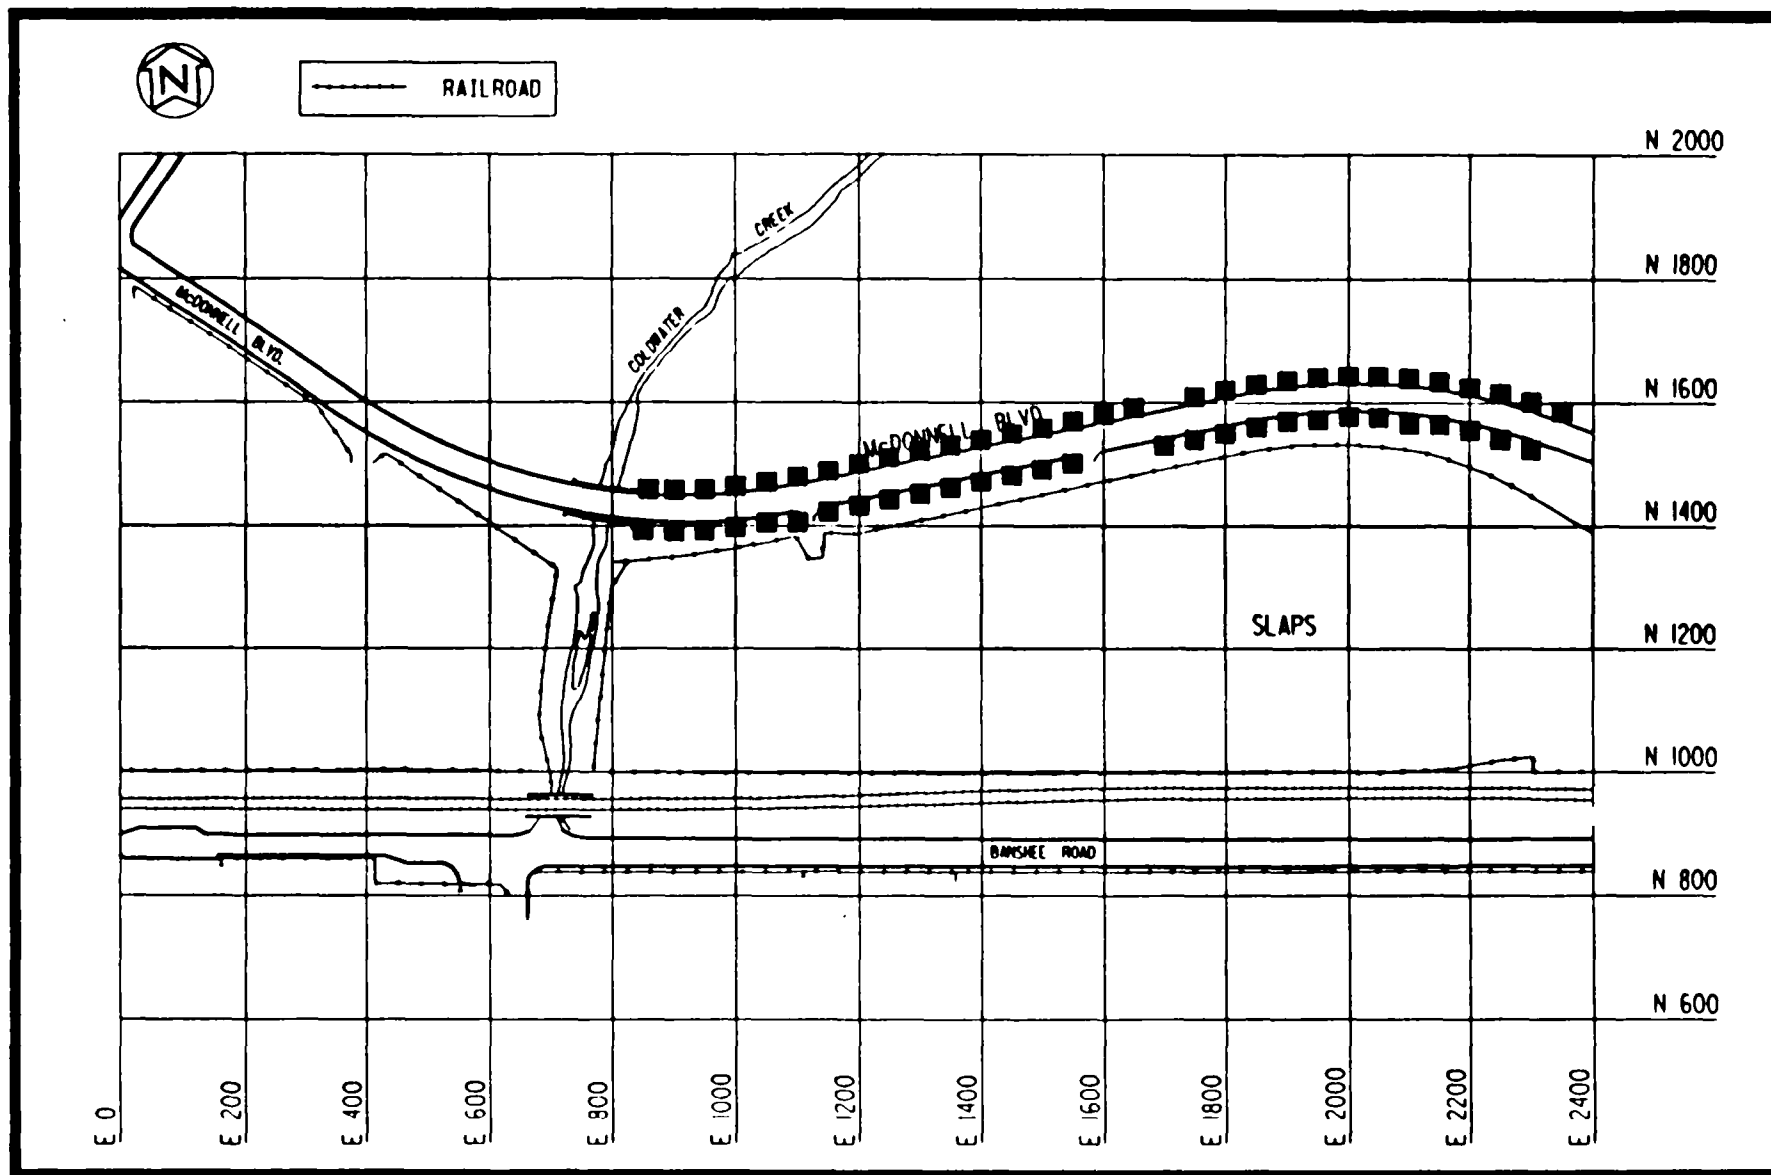
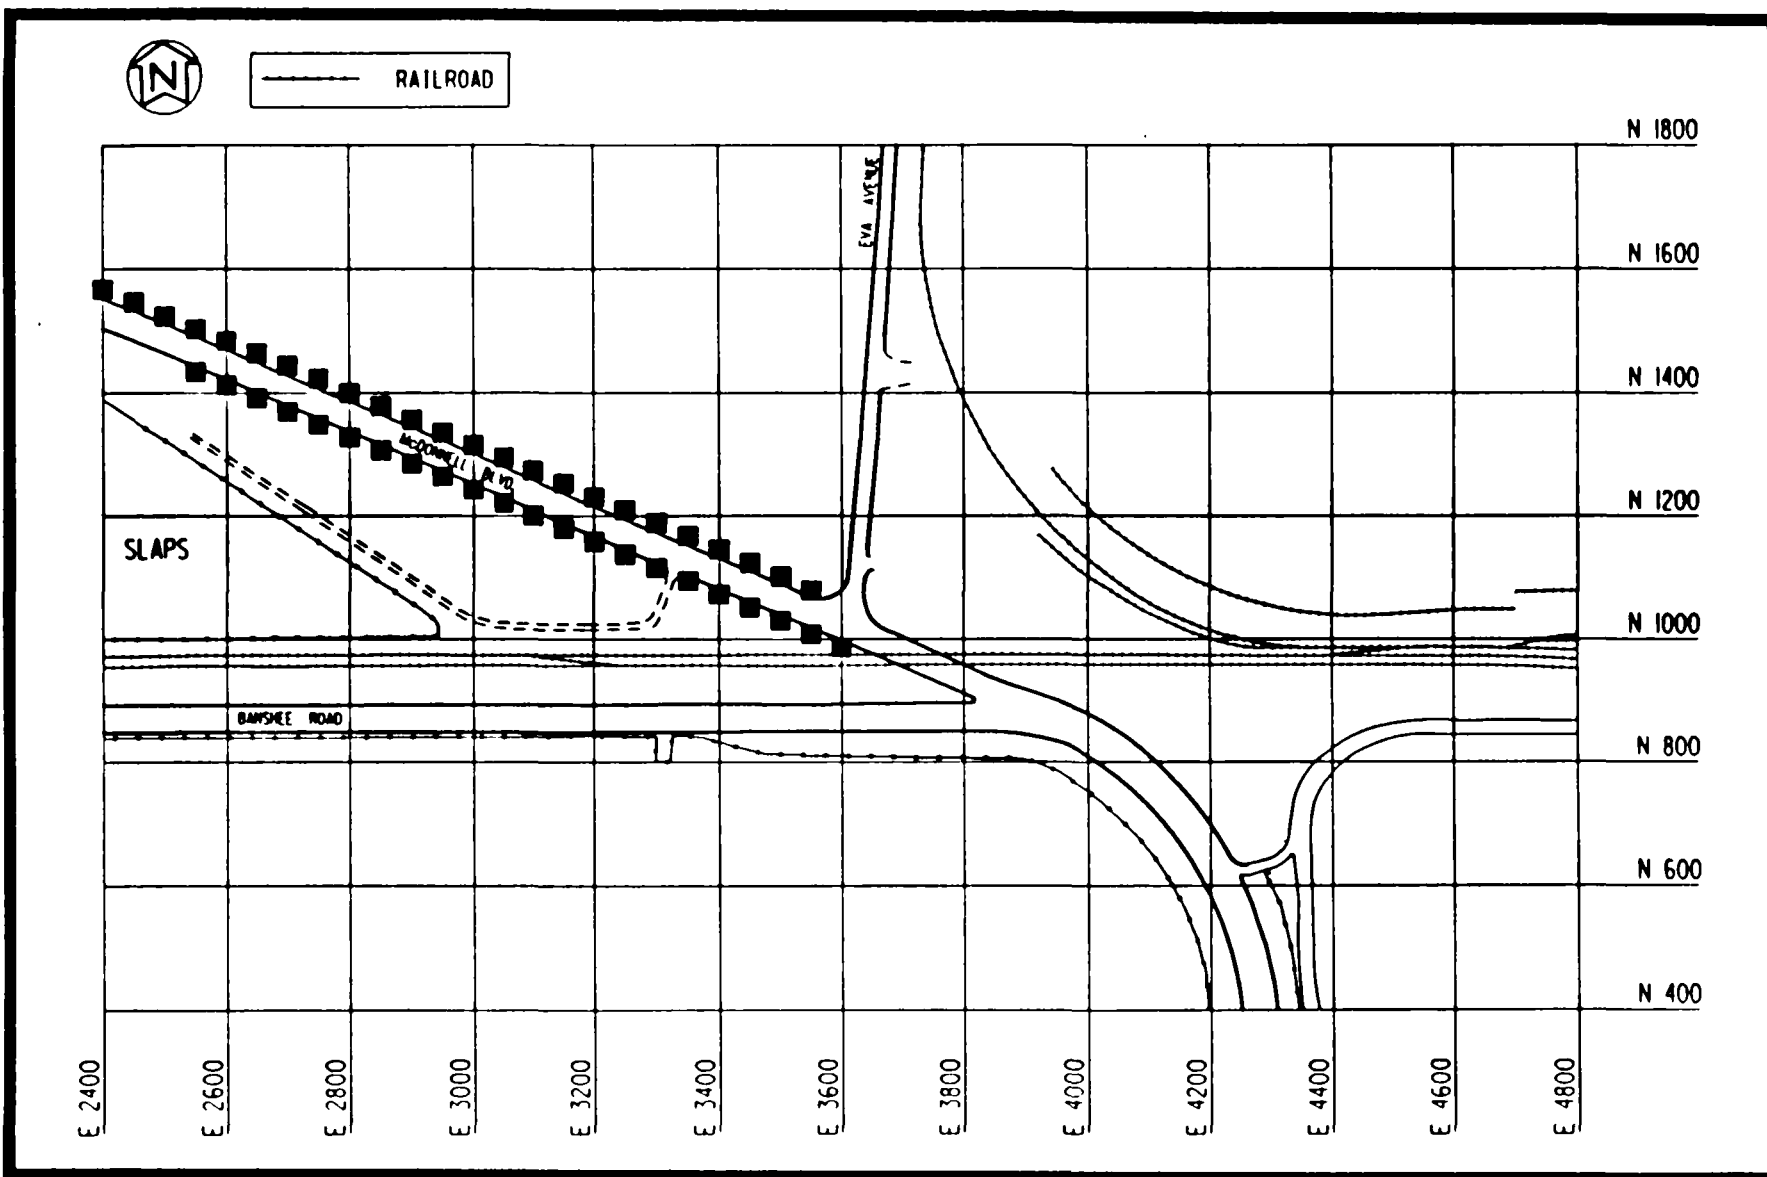
FIGURE 5-4 COMPOSITE SURFACE SOIL SAMPLING LOCATIONS FOR RADIOLOGICAL CHARACTERIZATION OF MCDONNELL BOULEVARD

Soil sampling locations at McDonnell Boulevard are shown in Figures 5-4, 5-5, and 5-6. Analytical results for soil collected at McDonnell Boulevard (Table 5-4) revealed areas with elevated concentrations of radium-226, thorium-232, and thorium-230 in the

composite samples. Elevated concentrations of thorium-230 also were detected in subsurface samples. Uranium-238 concentrations ranged from less than 2 to 59 pCi/g. Radium-226 concentrations ranged from 0.7 to 64 pCi/g. Concentrations of thorium-232 ranged from less than 0.7 to 9 pCi/g. Thorium-230 concentrations ranged from 0.7 to 2,900 pCi/g. Areas and depths of contamination are depicted in Figure 5-7. Contamination ranges from the surface to a depth of 4.5 m (15 ft) at one location and extends approximately 275 m (900 ft) east of Coldwater Creek and 122 m (400 ft) west of the creek. One isolated area of contamination, extending to a depth of 1.5 m (5 ft), exists near the intersection of McDonnell Boulevard and Eva Avenue.

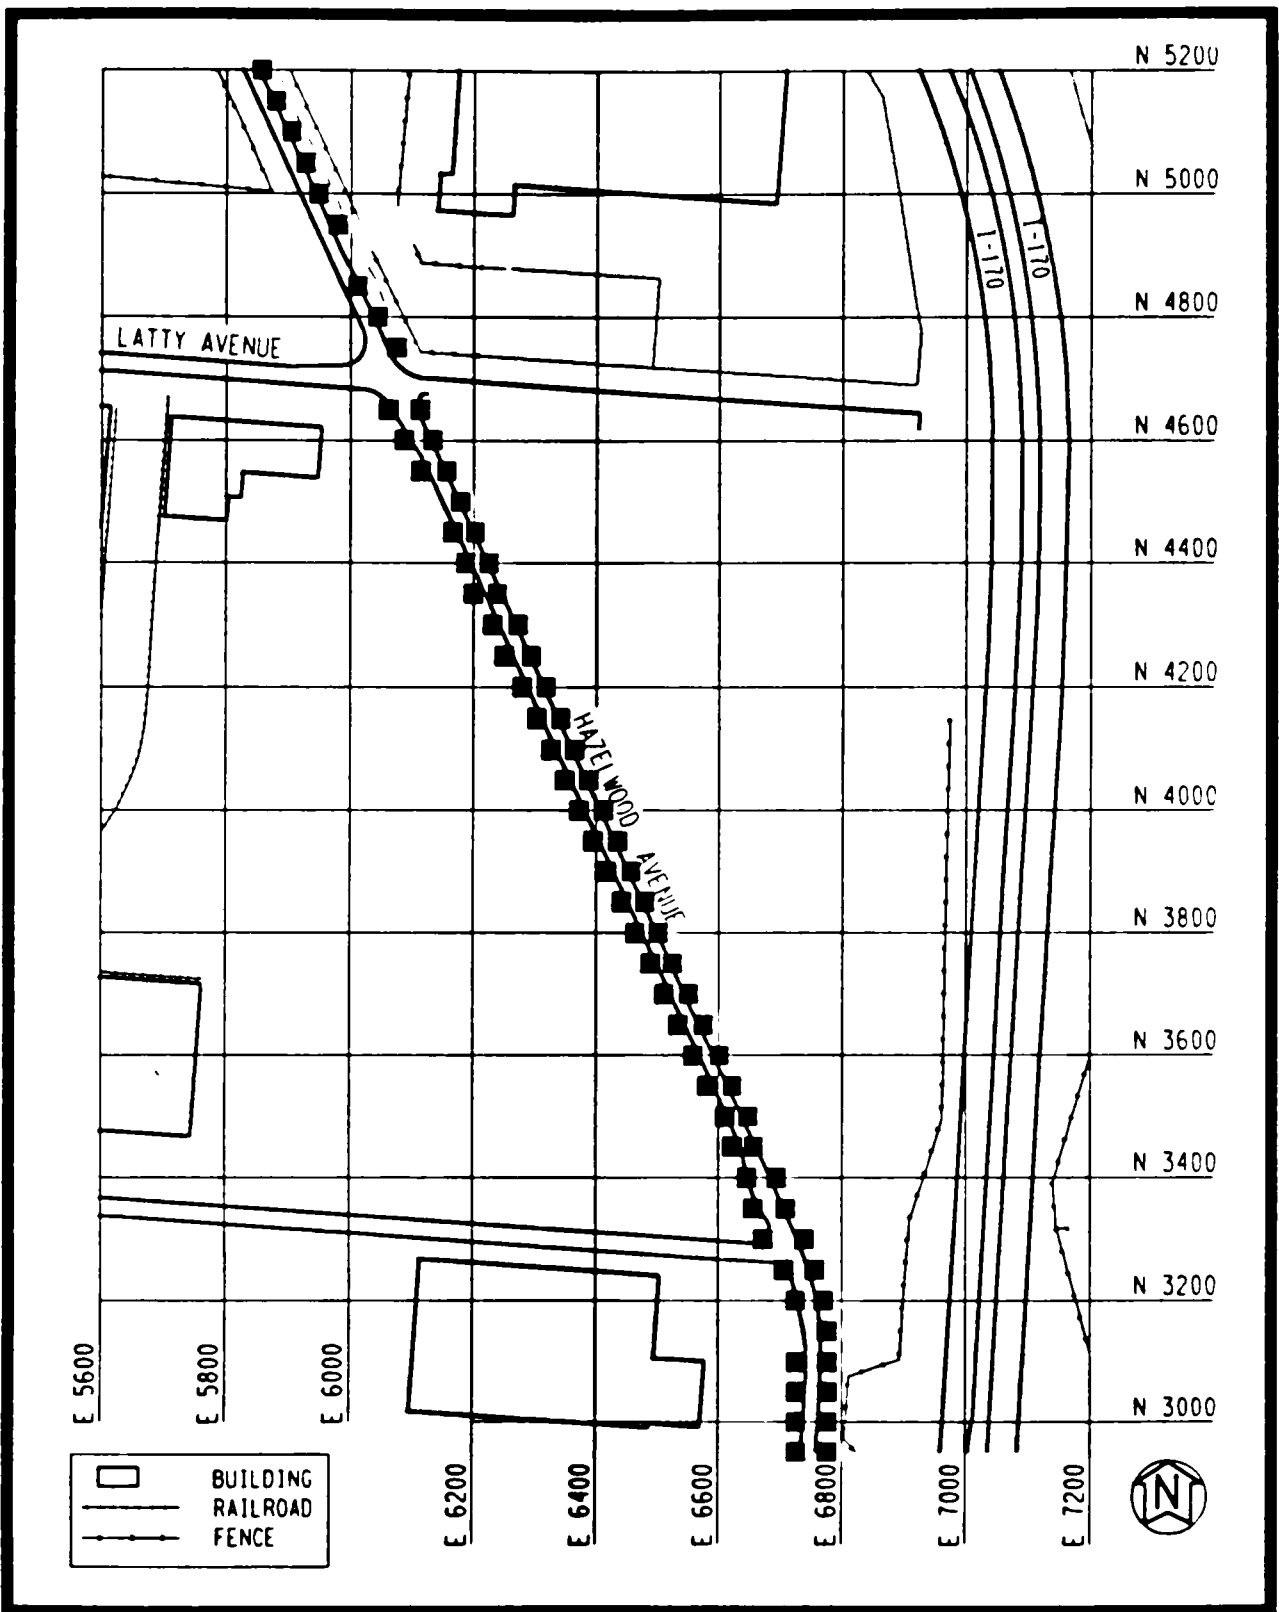
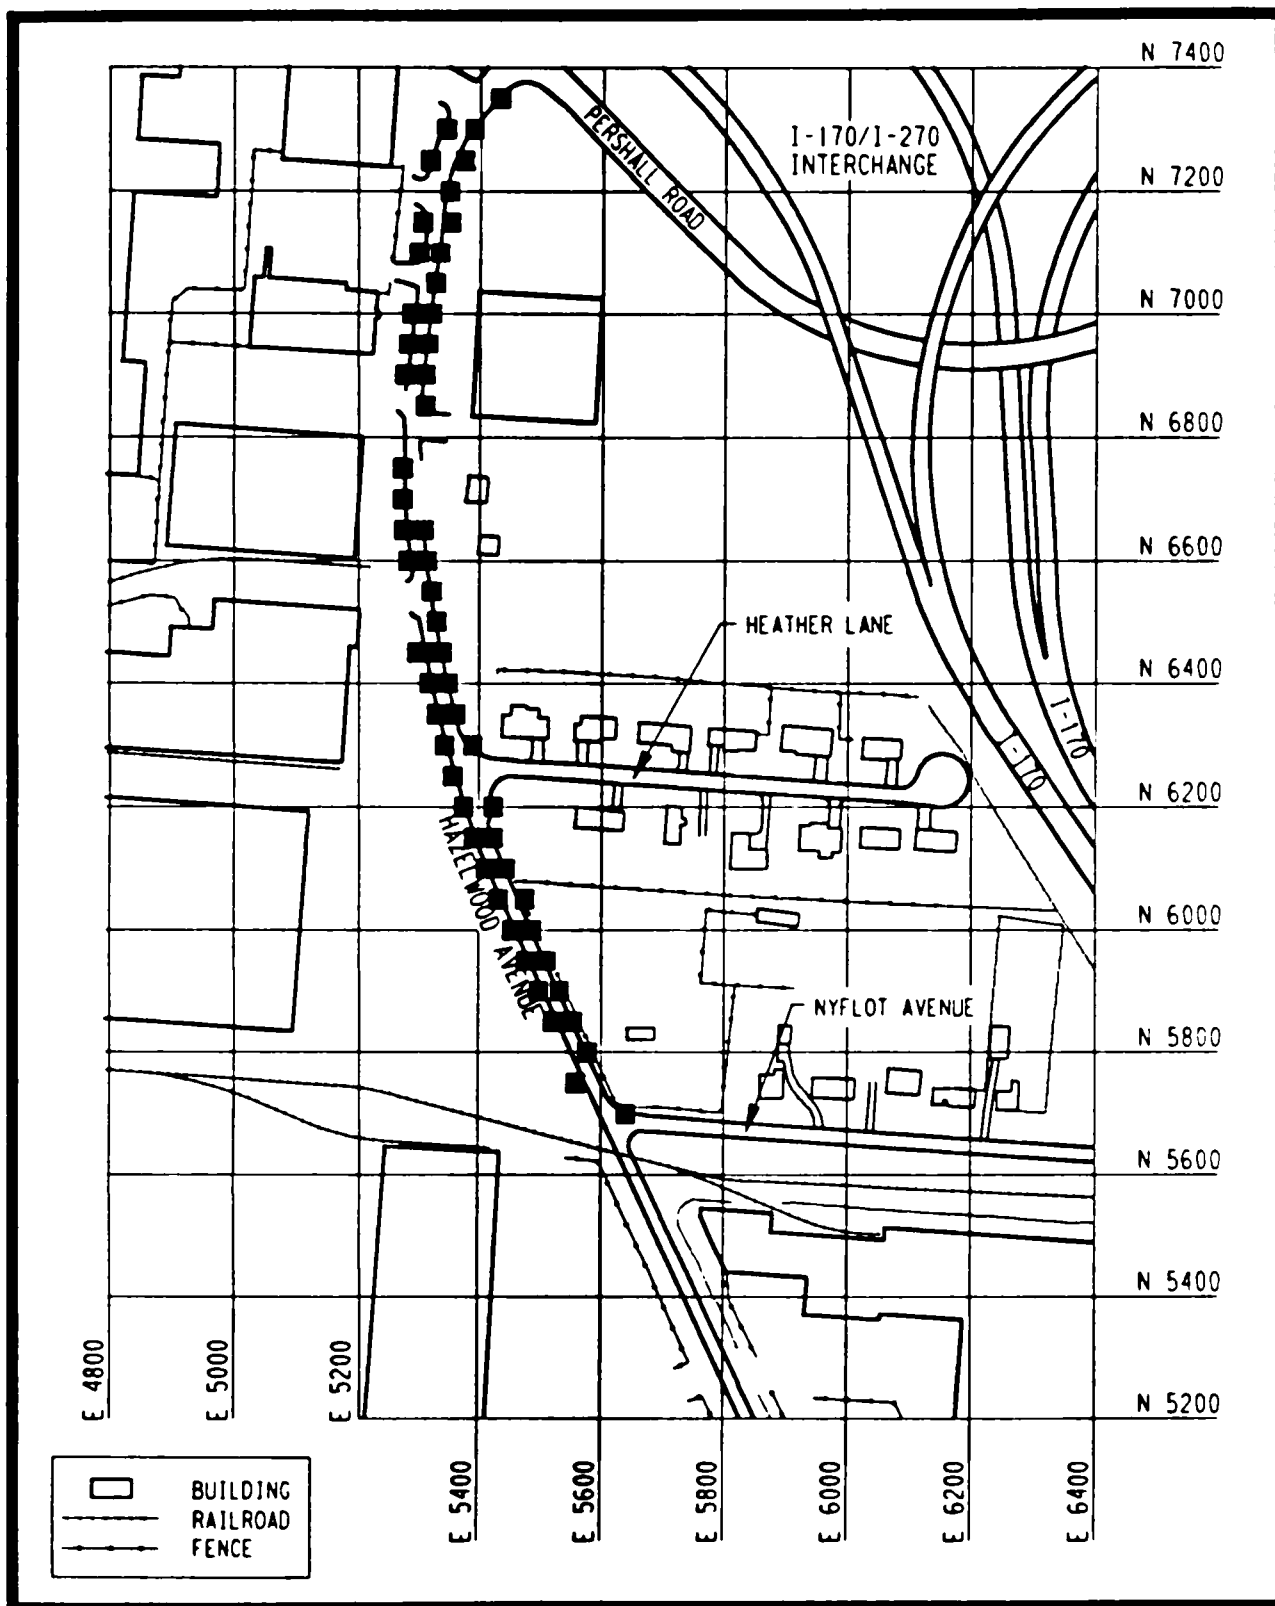
FIGURE 5-8 COMPOSITE SURFACE SOIL SAMPLING LOCATIONS FOR RADIOLOGICAL CHARACTERIZATION OF HAZELWOOD AVENUE

Soil sampling locations at Hazelwood Avenue are shown in Figures 5-8, 5-9, and 5-10. Analytical results for soil collected at Hazelwood Avenue (Table 5-6) showed areas with elevated concentrations of radium-226, thorium-232, and thorium-230 in the composite samples. Uranium-238 concentrations ranged from less than 4 to 72 pCi/g. Radium-226 concentrations ranged from 0.6 to 42 pCi/g. Concentrations of thorium-232 ranged from 0.8 to 9 pCi/g. Thorium-230 concentrations ranged from 0.9 to 4,810 pCi/g. Figure 5-11 shows the areas and depths of radioactive contamination at Hazelwood Avenue. Contamination exists along both sides of Hazelwood Avenue to an average depth of 0.3 m (1 ft) from Hazelwood Avenue's intersection with Frost Avenue to Pershall Road.

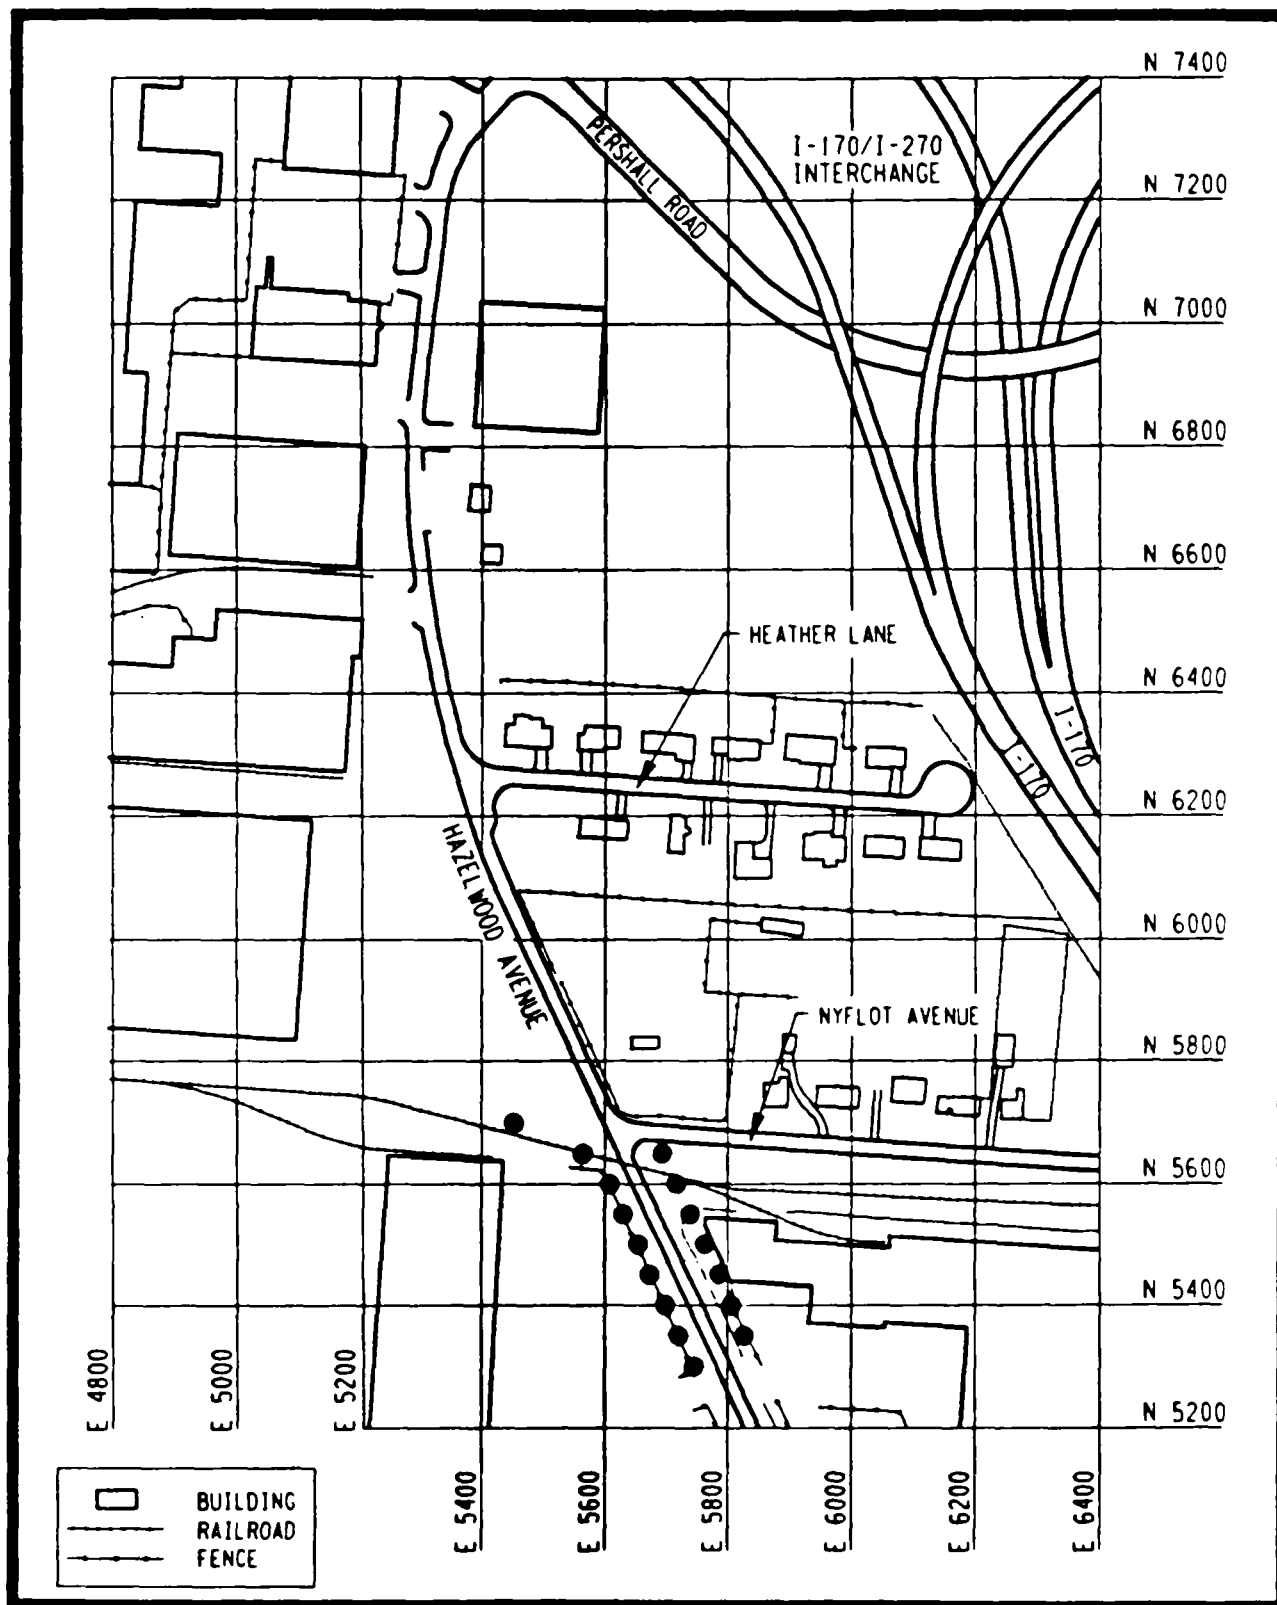
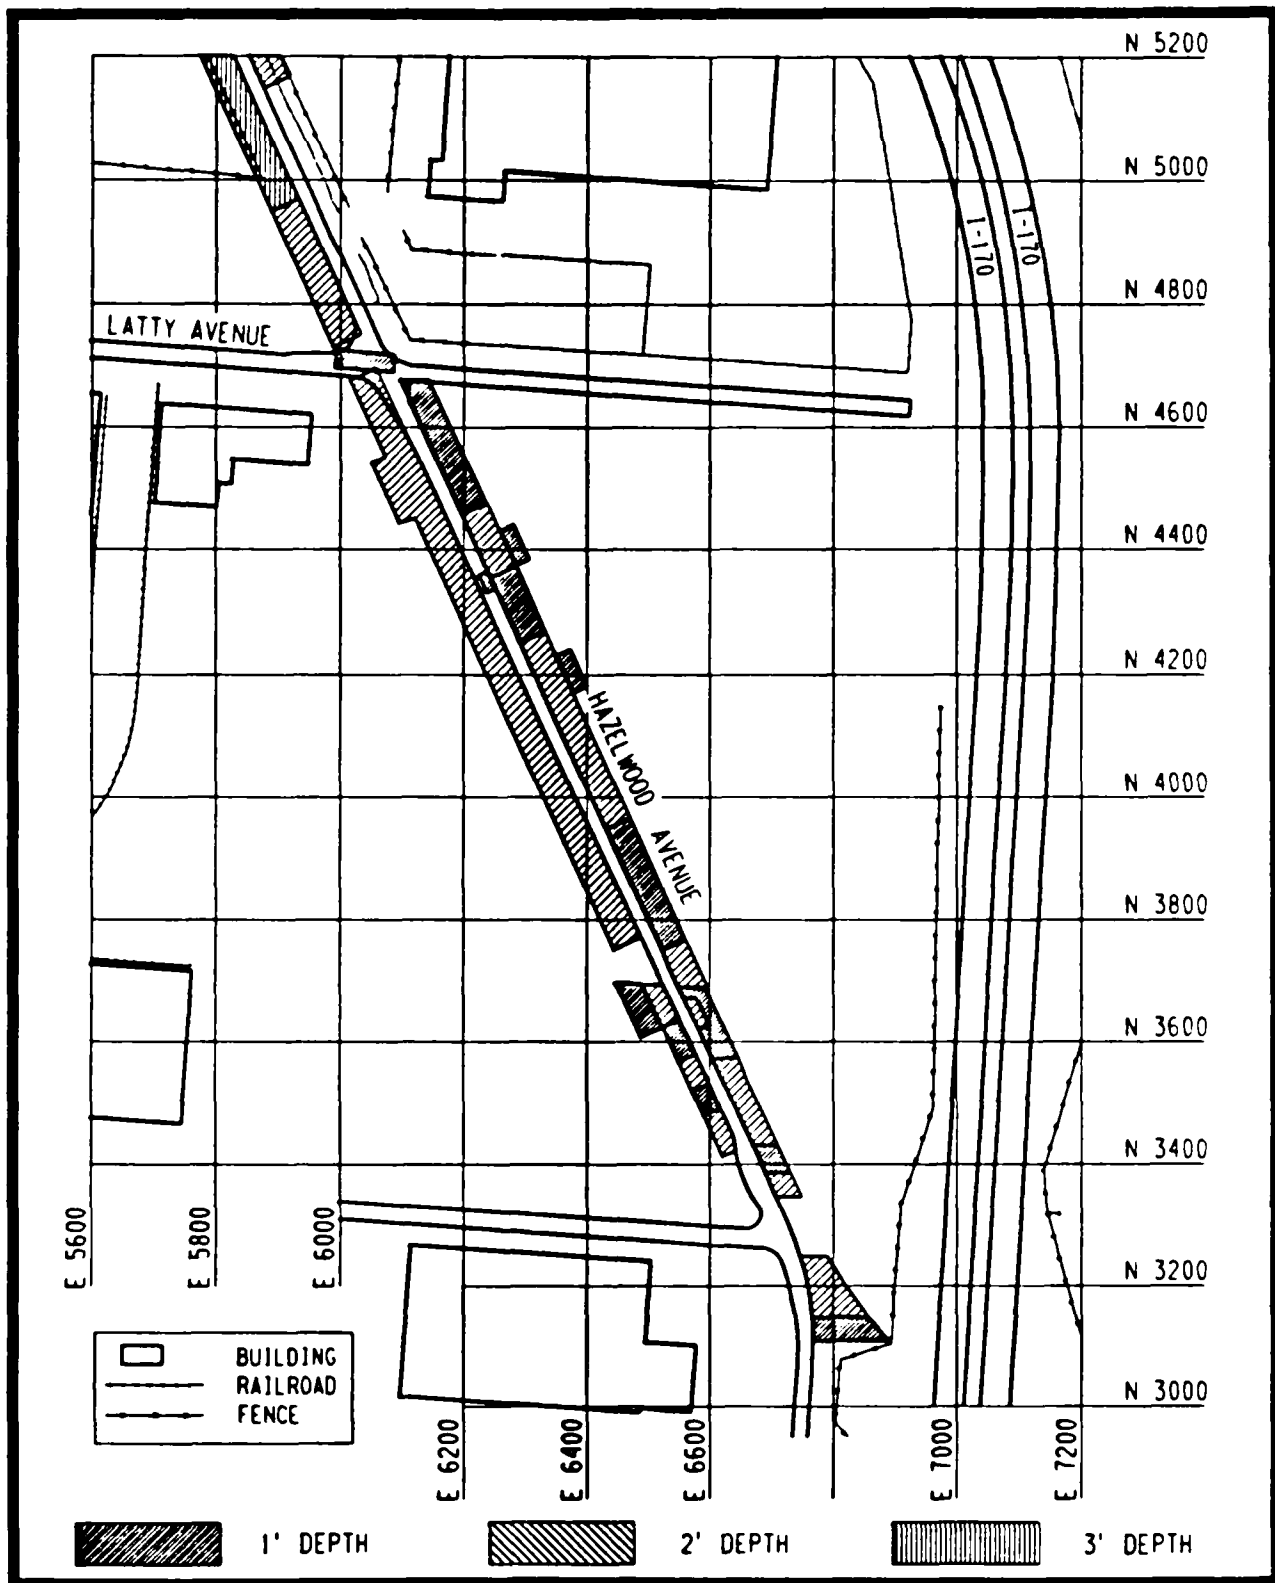
FIGURE 5-10 SUBSURFACE SOIL SAMPLING LOCATIONS FOR RADIOLOGICAL CHARACTERIZATION OF HAZELWOOD AVENUE

Properties 31A through 48A and Property 53 border Hazelwood Avenue. Characterization results from these properties show that contamination is generally confined to locations immediately adjacent to the road and is shallow [0.6 m (2 ft)]. Radioactive contamination is spotty along Hazelwood Avenue from its intersection with Frost Avenue to Pershall Road.

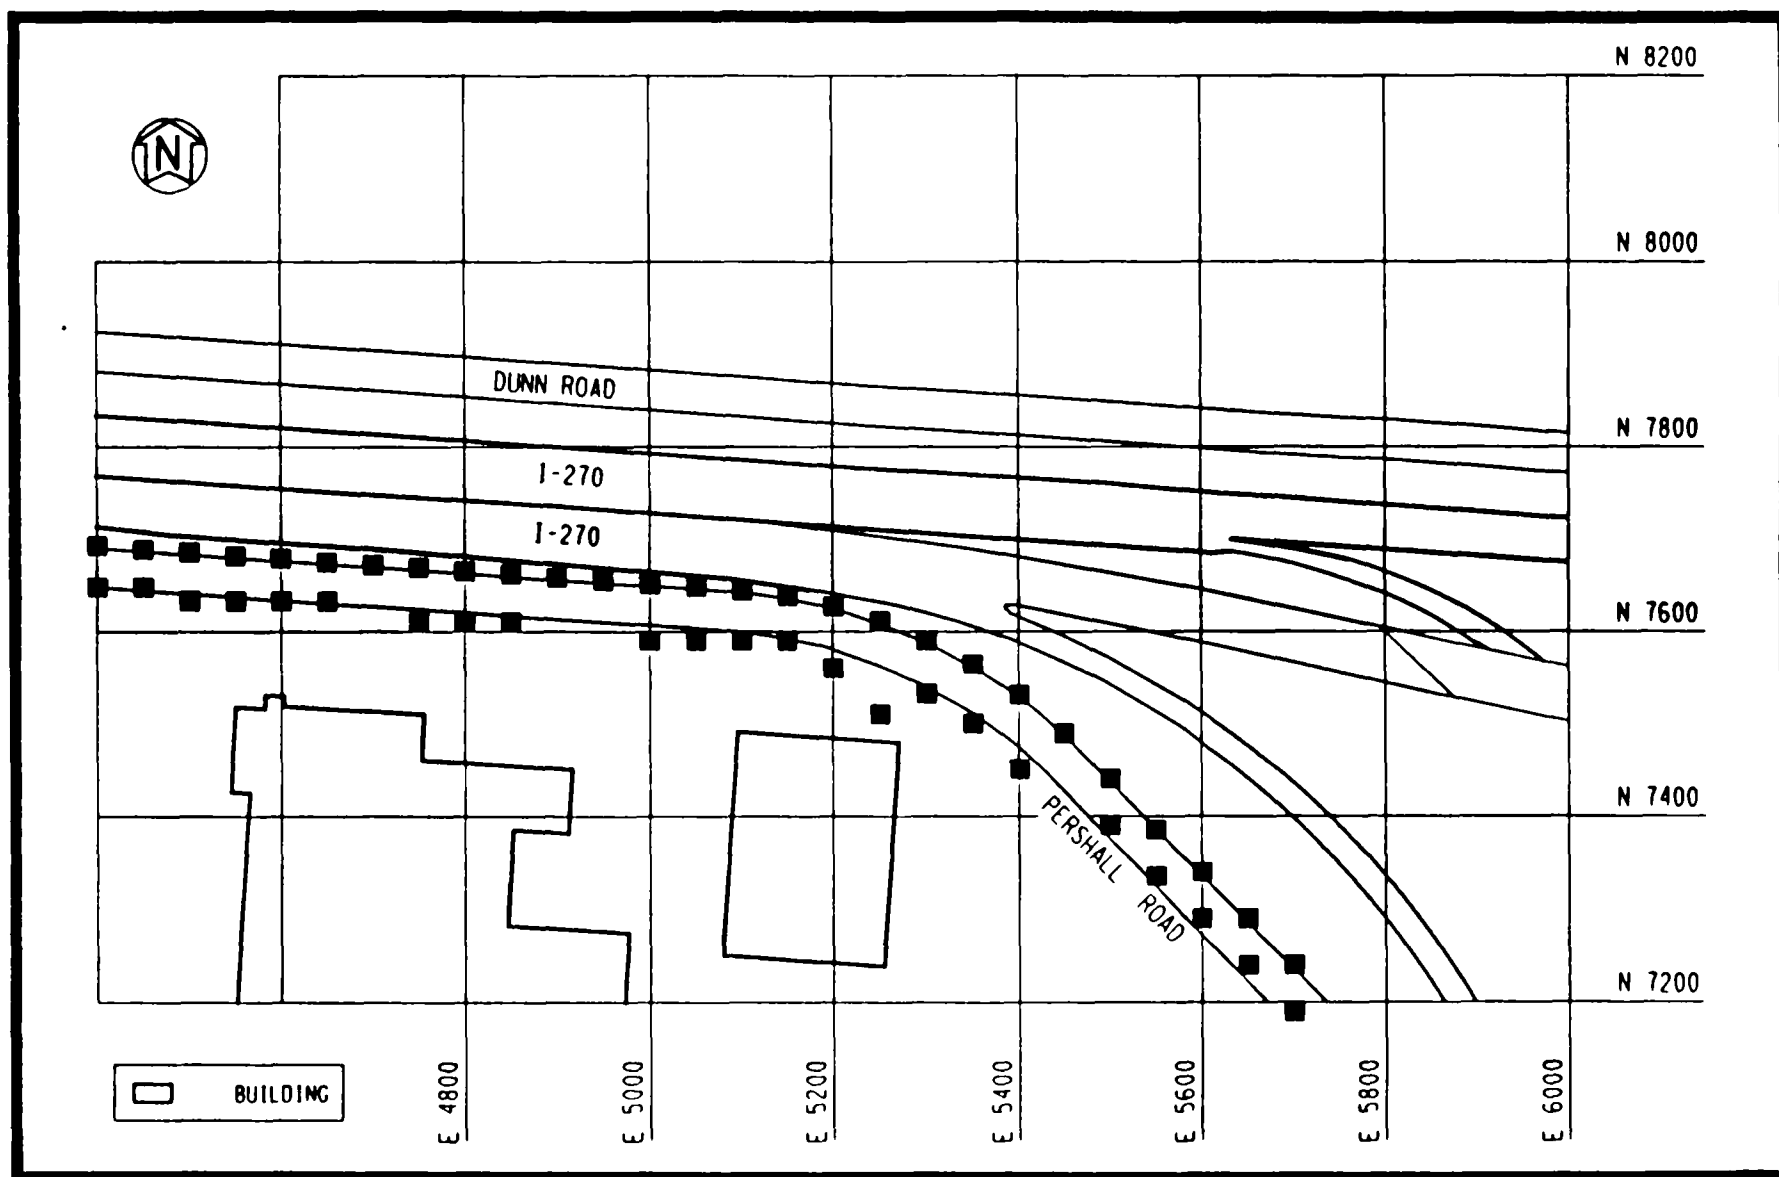
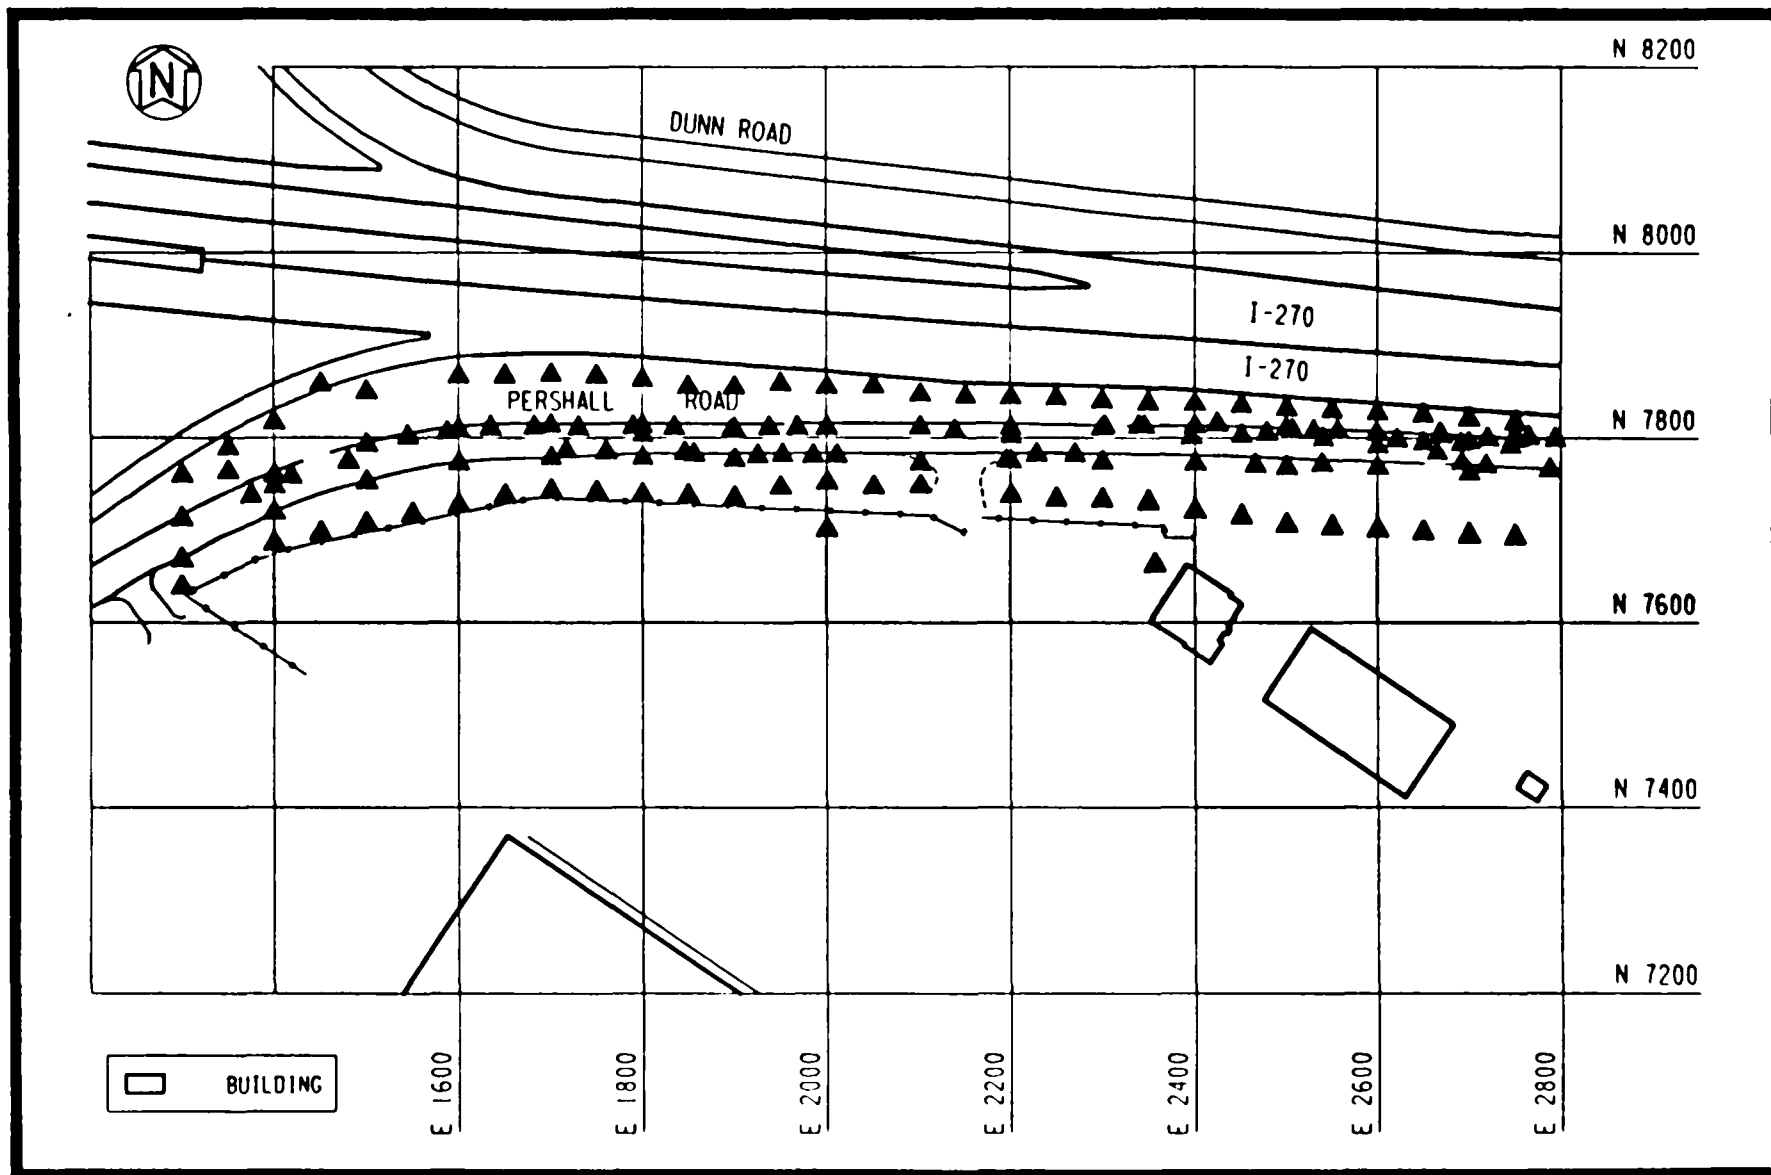
FIGURE 5-12 COMPOSITE SURFACE SOIL SAMPLING LOCATIONS FOR RADIOLOGICAL CHARACTERIZATION OF PERSHALL ROAD

Soil sampling locations at Pershall Road are shown in Figures 5-12, 5-13, and 5-14. Analytical results for soil collected at Pershall
